REV	DATE	DESCRIPTION	BY	DATE	APPROVED
B	10/12/2012	REVISED PIPING		10/12/2012	MIC
A	07/27/2012	REVISED PIPING LOCATION		07/27/2012	MIC
DEPARTMENT OF TRANSPORTATION FEDERAL AVIATION ADMINISTRATION ATO - TECHNICAL OPERATIONS CENTRAL SERVICE AREA ARTCC DOMESTIC HOT WATER PIPING REPLACEMENT SOUTH END BASEMENT DOMESTIC HOT WATER DEMOLITION PLAN					
HOUSTON AIR ROUTE TRAFFIC CONTROL CENTER TX					
REVIEWED BY	SUBMITTED BY	APPROVED BY			
	MICHAEL T. CARROLL	PETE HEAY			
DESIGNED BY	PROJECT ENGINEER	MGR. ENGINEERING - FORT WORTH	DATE	03/22/2012	REV
			ISSUED BY		R08798
DRAWN	ENG	ENGINEERING SERVICES	DRAWING NO.	ZHU-D-ARTCC-M026	REV
CHECKED	ENR	ENROUTE/FSO			B

Project: ZHU

Test Report: Asbestos Analysis of Bulk Materials via EPA 600/R-93/116 Method using Polarized Light Microscopy

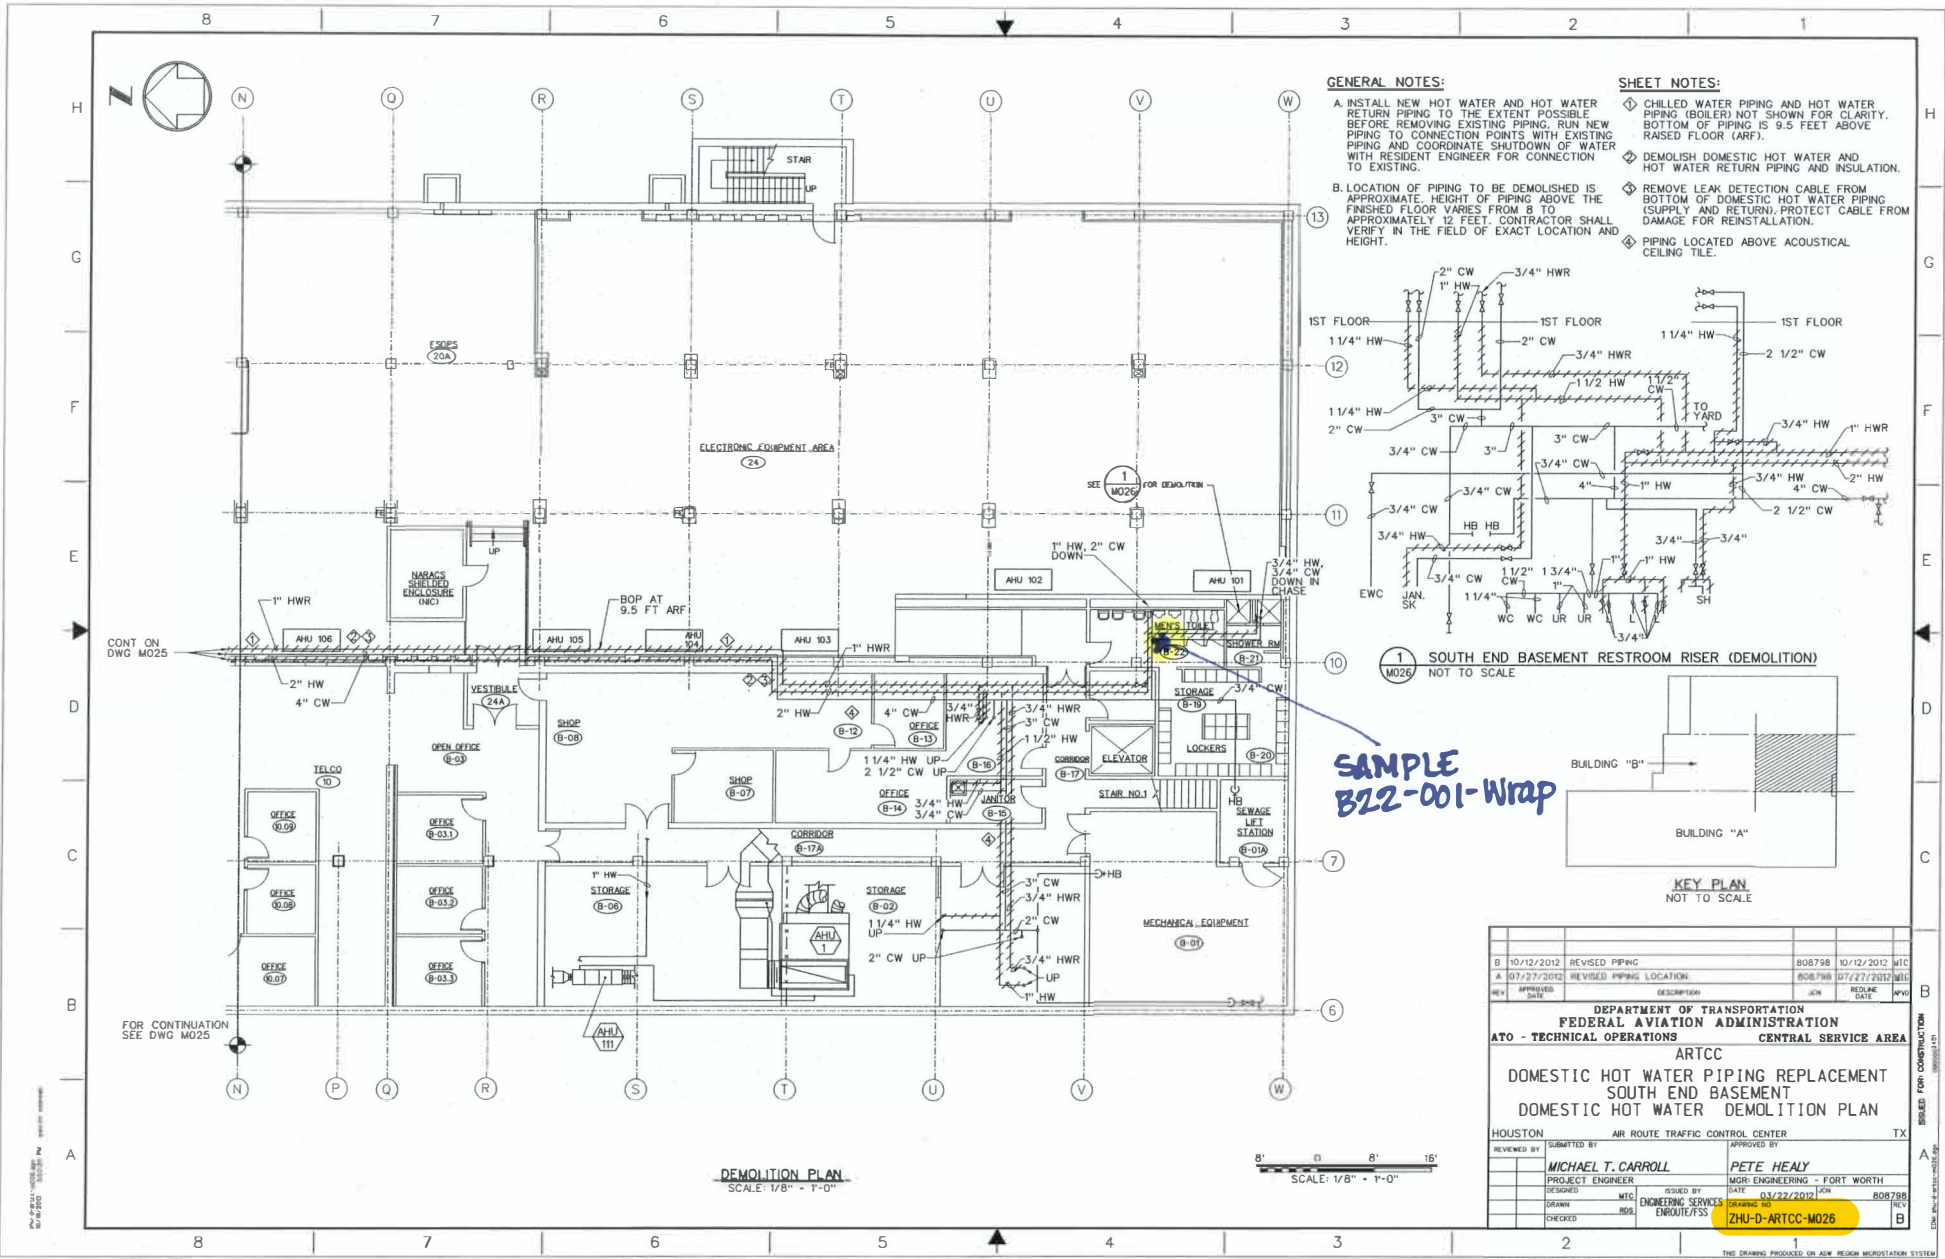
DEMOLITION PLAN
SCALE: 1/8" = 1'-0"

SAMPLE B22-001-Wrap

Sample	Description	Appearance	Non-Asbestos		Asbestos
			% Fibrous	% Non-Fibrous	% Type
B22-001-Wrap <small>151608614-0001</small>	Rm B22 - Above Ceiling Tiles Hot water Line - Pipe Insulation	White Fibrous Homogeneous		95% Non-fibrous (Other)	5% Chrysotile
B22-001-Insulation <small>151608614-0001A</small>	Rm B22 - Above Ceiling Tiles Hot water Line - Pipe Insulation	Gray Fibrous Homogeneous	5% Cellulose 40% Min. Wool	20% Ca Carbonate 35% Non-fibrous (Other)	None Detected
B29-001-Wrap <small>151608614-0002</small>	Rm 29 - Elevator Eq. Rm. Water Line - Pipe Insulation	Gray/White/Silver Fibrous Homogeneous	15% Cellulose	85% Non-fibrous (Other)	None Detected
B29-001-Mastic <small>151608614-0002A</small>	Rm 29 - Elevator Eq. Rm. Water Line - Pipe Insulation	Black Non-Fibrous Homogeneous		100% Non-fibrous (Other)	None Detected
B29-001-Insulation <small>151608614-0002B</small>	Rm 29 - Elevator Eq. Rm. Water Line - Pipe Insulation	Tan Non-Fibrous Homogeneous		100% Non-fibrous (Other)	None Detected
