REV	DATE	DESCRIPTION	BY	DATE	APPROVED
B	10/12/2012	REVISED PIPING		10/12/2012	MIC
A	07/27/2012	REVISED PIPING LOCATION		07/27/2012	MIC
DEPARTMENT OF TRANSPORTATION FEDERAL AVIATION ADMINISTRATION ATO - TECHNICAL OPERATIONS CENTRAL SERVICE AREA ARTCC DOMESTIC HOT WATER PIPING REPLACEMENT SOUTH END BASEMENT DOMESTIC HOT WATER DEMOLITION PLAN					
HOUSTON AIR ROUTE TRAFFIC CONTROL CENTER TX					
REVIEWED BY	SUBMITTED BY	APPROVED BY			
	MICHAEL T. CARROLL	PETE HEAY			
DESIGNED BY	PROJECT ENGINEER	MGR. ENGINEERING - FORT WORTH	DATE	03/22/2012	REV
			ISSUED BY		R08798
DRAWN	ENG	ENGINEERING SERVICES	DRAWING NO.	ZHU-D-ARTCC-M026	REV
CHECKED	ENR	ENROUTE/FSO			B

Project: ZHU

Test Report: Asbestos Analysis of Bulk Materials via EPA 600/R-93/116 Method using Polarized Light Microscopy

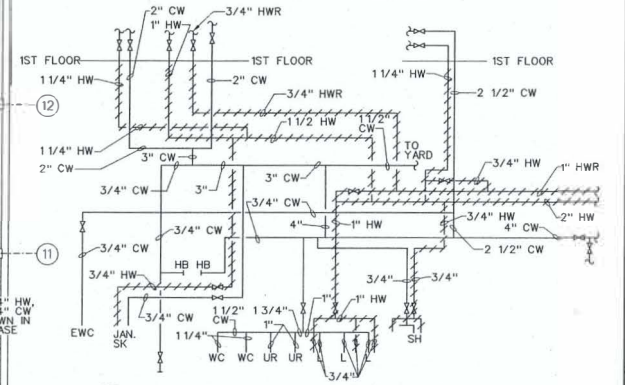
1 SOUTH END BASEMENT RESTROOM RISER (DEMOLITION)
NOT TO SCALE

- 1. CHILLED WATER PIPING AND HOT WATER PIPING (BOILER) NOT SHOWN FOR CLARITY. BOTTOM OF PIPING IS 9.5 FEET ABOVE RAISED FLOOR (ARF).
- 2. DEMOLISH DOMESTIC HOT WATER AND HOT WATER RETURN PIPING AND INSULATION.
- 3. REMOVE LEAK DETECTION CABLE FROM BOTTOM OF DOMESTIC HOT WATER PIPING (SUPPLY AND RETURN); PROTECT CABLE FROM DAMAGE FOR REINSTALLATION.
- 4. PIPING LOCATED ABOVE ACOUSTICAL CEILING TILE.

SAMPLE B22-001-Wrap
