# **CLARK SHAFT EVALUATION ADDENDUM**

UNIVERSITY OF TEXAS MD ANDERSON CANCER CENTER

B1511740  
DATE: 2017-06-09

WSP USA  
SUITE 200  
808 TRAVIS STREET  
HOUSTON, TX 77002

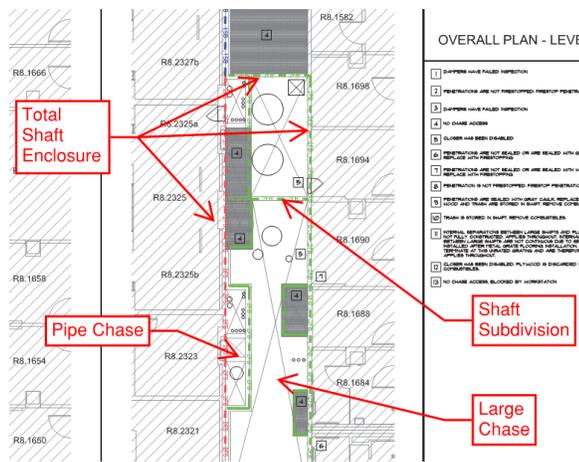
The findings and recommendations below describe both Total Shaft Enclosure and Shaft Subdivision deficiencies. Shaft Subdivision wall findings and recommendations include subdivision walls both between large chases and pipe chases. Figure 1 below provides an example floor to illustrate the language used in this report include TSE, SS, Pipe Chase, and Large Chase.
